Safe Tractor Access Platforms: From Guidance Material to Implementation

L. Day, G. Rechnitzer

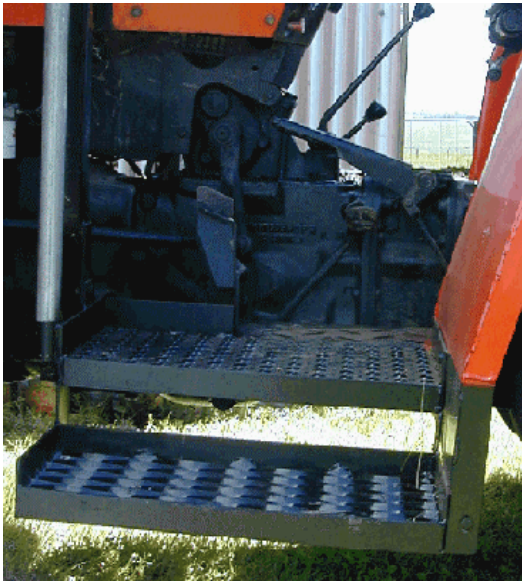
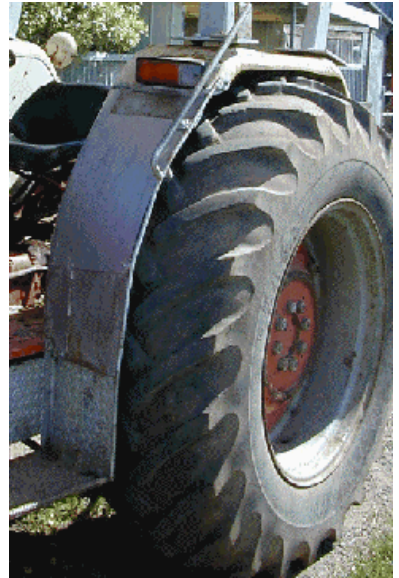
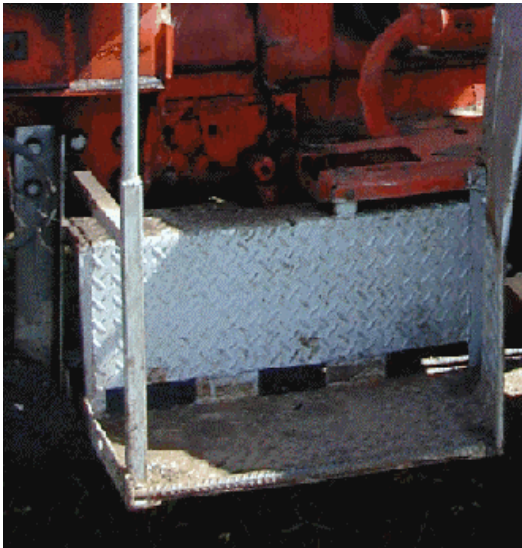
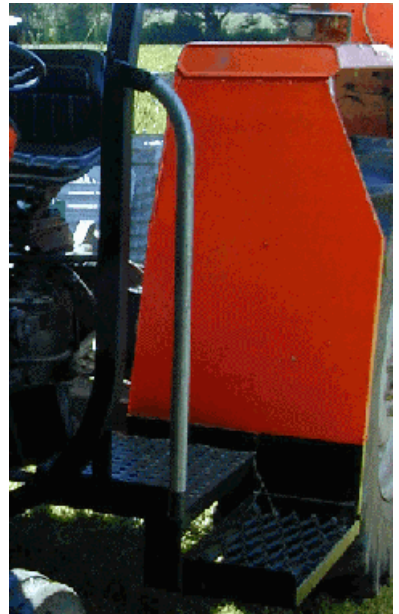
Although not specifically mentioned in the guidelines, the design and positioning of some steps did not provide unimpeded access, although access had been improved. For example, “split-leveling” of the top step can be seen in figure 1.

Figure 1. Positioning of steps with respect to driver platform and mudguard width (safe tractor access platform evaluation, Victoria, 2001–2002).

There was a tendency on some retrofitted tractors to be unnecessarily constrained by the dimensions and positioning of the driver platform and the mudguard width. This resulted in the outer edge of the bottom step being recessed with respect to the outer edge of the rear wheel, and in insufficient guarding of the rear wheel by the mudguard (fig. 2, left).

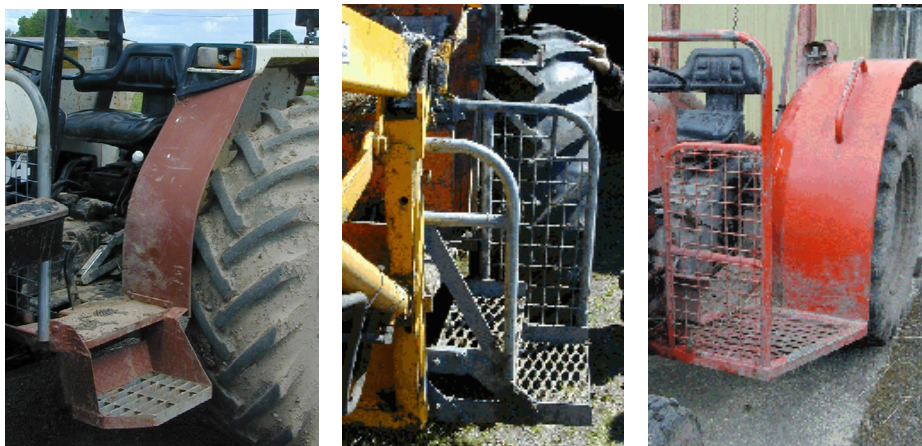
The guidelines recommend that a guard be placed between the access platform and the tractor mudguard, to prevent contact between the rear wheel and the operator. However, the mudguard itself could be expected to prevent this contact if it covers the full width of the tire face. Adequate protection was provided by the rear wheel mudguard on three tractors, and by a guard attached to the platform on a further two tractors. This guard was formed from the rear handrail attached to the platform and with the resulting space filled in with wire mesh (fig. 2).

Figure 2. Examples of guarding of rear wheel: (left) incomplete guarding of rear wheel, (middle) complete guarding of rear wheel by rear handrail and wire mesh, and (right) complete guarding with mudguard (safe tractor access platform evaluation, Victoria, 2001–2002).

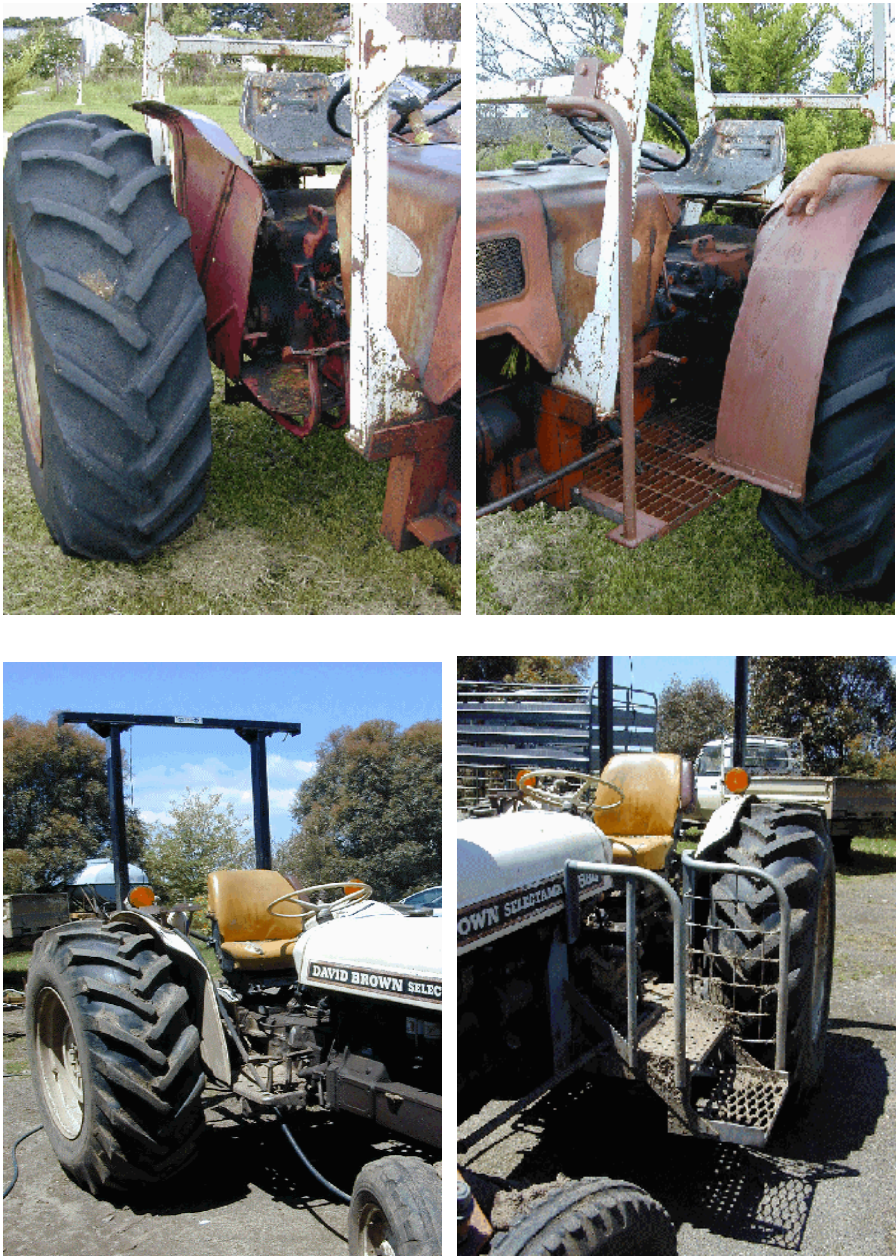
Figure 3. Examples of (left, top and bottom) pre-retrofit and (right, top and bottom) post-retrofit tractors (safe tractor access platform evaluation, Victoria, 2001–2002).
