Monash Rehabilitation Technology Research Unit

**Experimental Investigation
of the Decaying
Performance of
Hydraulic Knee
Controllers**

EXPERIMENTAL INVESTIGATION OF THE DECAYING PERFORMANCE OF HYDRAULIC KNEE CONTROLLERS

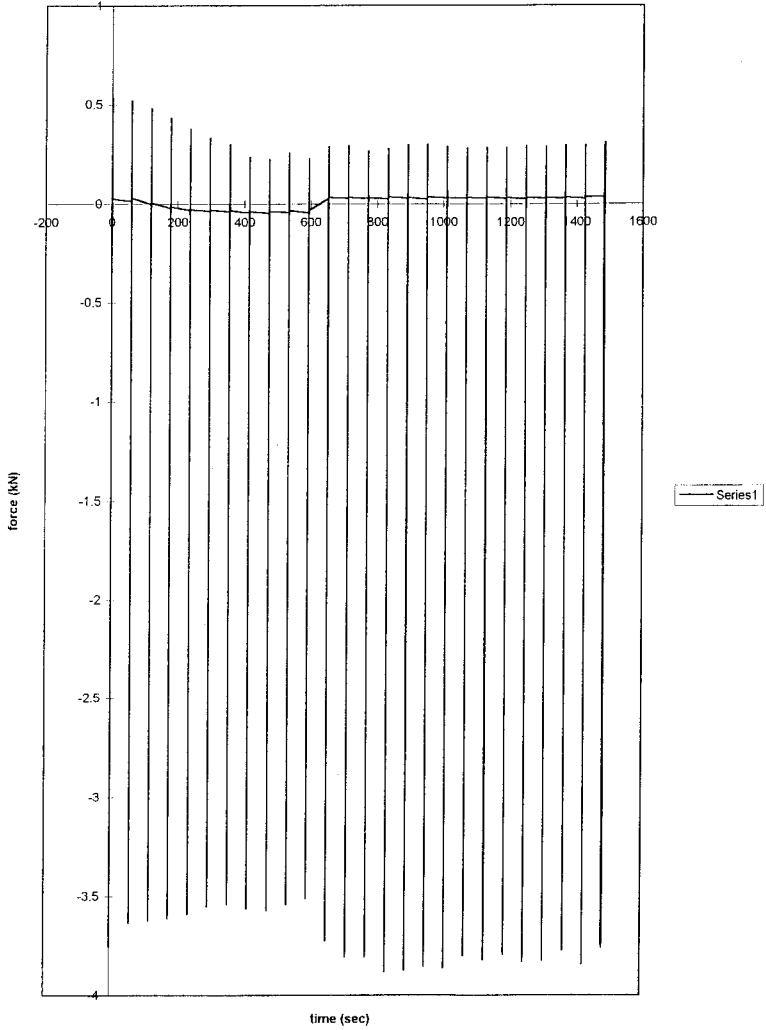
APPENDIX C

The test results are outlined in APPENDIX C. Initially the test was planned to run for two hours, however excessive heating of the unit occurred. Within ten minutes the unit was operating at temperatures above 70°C. After 25 minutes the test was stopped since the outside casing of the unit was well above 90°C. The large temperature change was unexpected, and the characteristics did not change significantly. There was a shifting in the force requiring less force to extend the knee and more force to put the knee in flexion. This however could be explained by an expansion of the spring due to temperature, and a larger force required to fully displace it, resulting in a lesser force to return it to its equilibrium position.

25 minute endurance test at medium settings for flexion and extension
